Performance of Soil Nail Stabilisation Works for a 14.5m Deep Excavation in Uncontrolled Fill Ground

S. S. Liew & C. M. Khoo

G&P Geotechnics Sdn Bhd, Wisma G&P, Bandar Tasik Selatan, Kuala Lumpur, Malaysia.

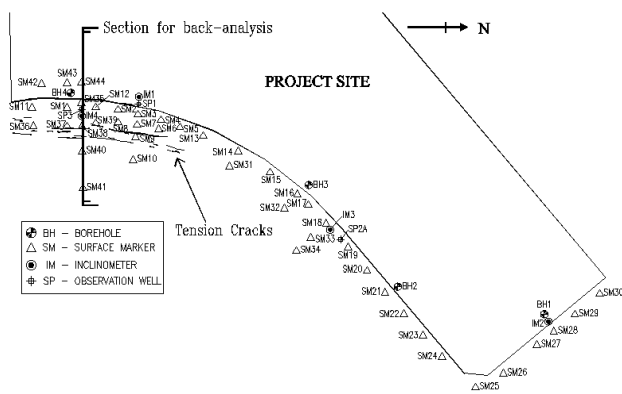
Fig. 4 Subsurface investigation and instrumentation layout

Subsurface investigation (SI) was carried out to establish the subsurface conditions for the geotechnical investigation and design of slope stabilisation work. The SI layout is presented in Fig. 4 together with the instrumentation layout. Fig. 5 shows the interpreted boreholes logging. The fill material mainly consists of sandy silt with SPT-N values generally ranging from 0 to 20. A layer of soft material was detected at the depth of 12m to 15m below the ground surface in two boreholes (BH-IM1 and BH-IM4) near the previous valley.

An extensive instrumentation programme consisting of four inclinometers, three observation wells, forty-four (44) surface displacement markers and strain gauges was planned and implemented to investigate the probable causes of the slope distresses, to monitor the performance of the stabilisation work and to provide validation for the designed nail resistance and potential groundwater variation. The instrumentation layout is shown in Fig. 4.

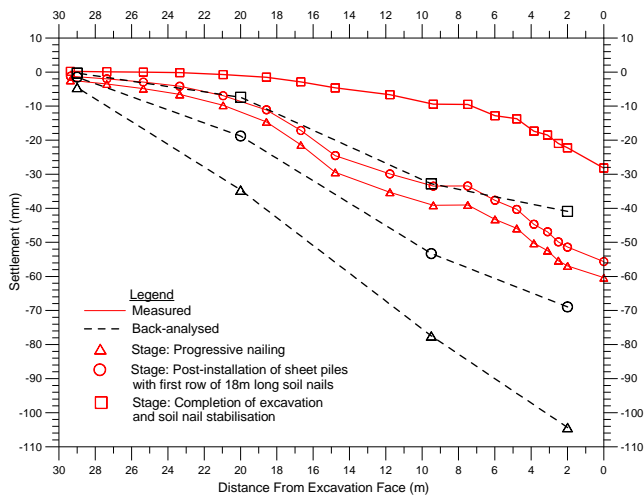
Fig. 9 Comparison of settlement on retained ground

The ground surface settlement measured from settlement markers installed on the retained ground perpendicular to the alignment of excavation and the FE back-analysis results are presented in Fig. 9. Generally, the settlement markers indicate a larger ground settlement magnitude as compared to the FE back-analysis results. The soil nail stabilisation works deployed high compressed air flushing the soil to form a pre-drilled open hole, which is similar to a micro tunneling. The excessive ground loss and stress relief in the soil extraction process have thus contributed further ground settlement in addition to the one caused by excavation. Even after the completion of nailing work, the terrain deformation may continue at a decreasing rate depending on the method of grouting the holes (Dulacska, 1992). In order to improve such conditions, the displacement type of reinforcing elements can be considered to reduce ground loss and stress relief induced settlement. In a case study of deep excavation using jack-in anchors presented by Liew, et al (2003), there was no abnormal ground settlement.

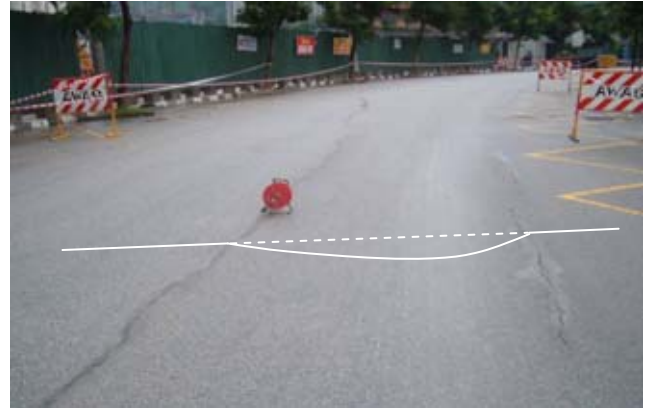
Fig. 10 Subsidence trough developed on the retained ground.

On the other hand, subsidence troughs developed on the retained ground surface (see Fig. 10) could also be observed from the FE back-analysis results. The results show that surface subsidence is generally expected at a distance of 8m from the excavated face, which tallies extremely well with the site conditions. The location of the trough is just immediately behind the end of the soil nail where high shear strain is generated as explained in the following section.

The settlement profile seems to taper off at a distance of 30m from excavation, which is near to the existing commercial buildings. One reason of such settlement profile could be the shielding effect caused by the presence of these commercial buildings supported on deep foundation obstructing the propagation of the ground settlement. Nonetheless, it generally tallies well with the ratio of actual ground settlement.
